Appendix E1
Cambria Emergency Water Supply
Project San Simeon Creek Basin
Groundwater Modeling Report

Cambria Emergency Water
Supply Project
**San Simeon Creek Basin
Groundwater Modeling
Report**

Cambria, California
May 2014

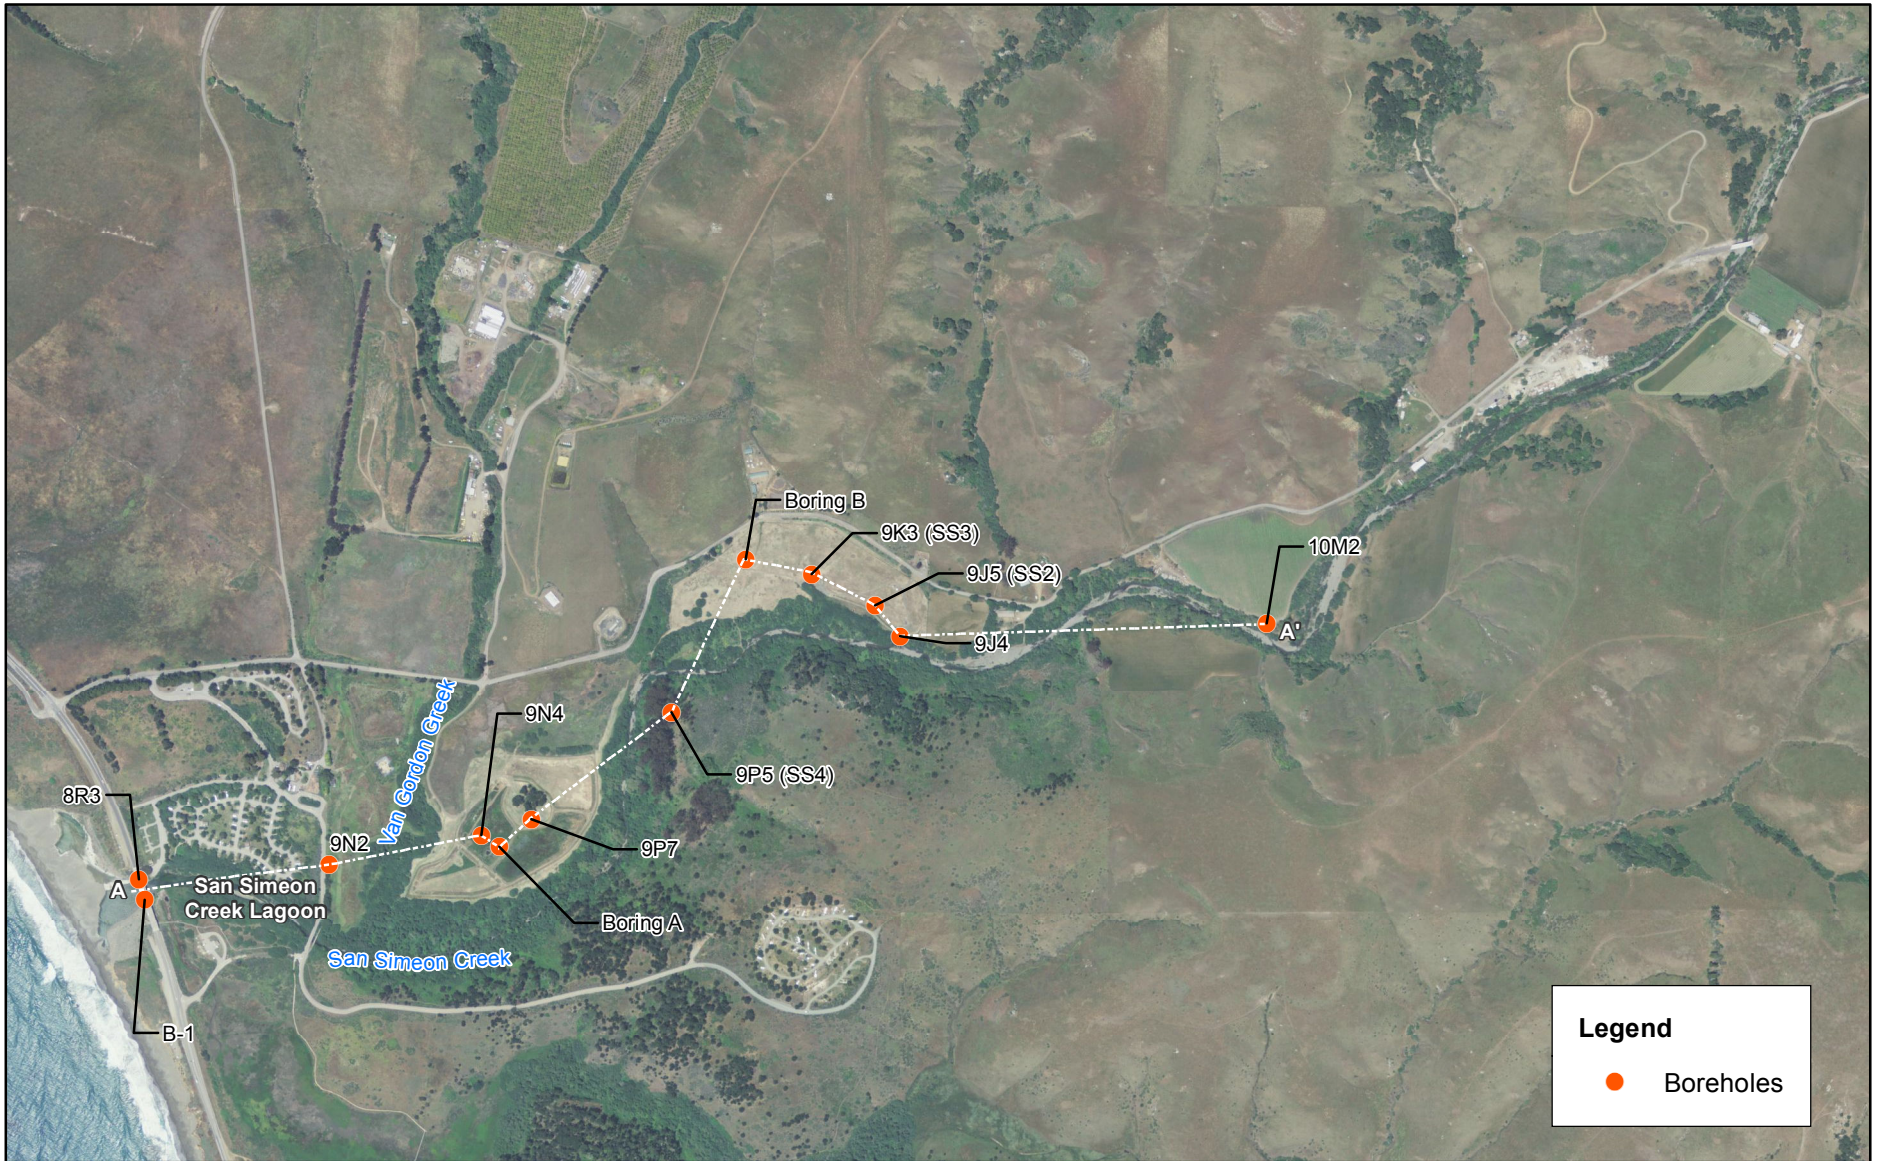
Figure 2-1
Location of Wells and Borings with Lithologic Data

Note: From Yates(1998)

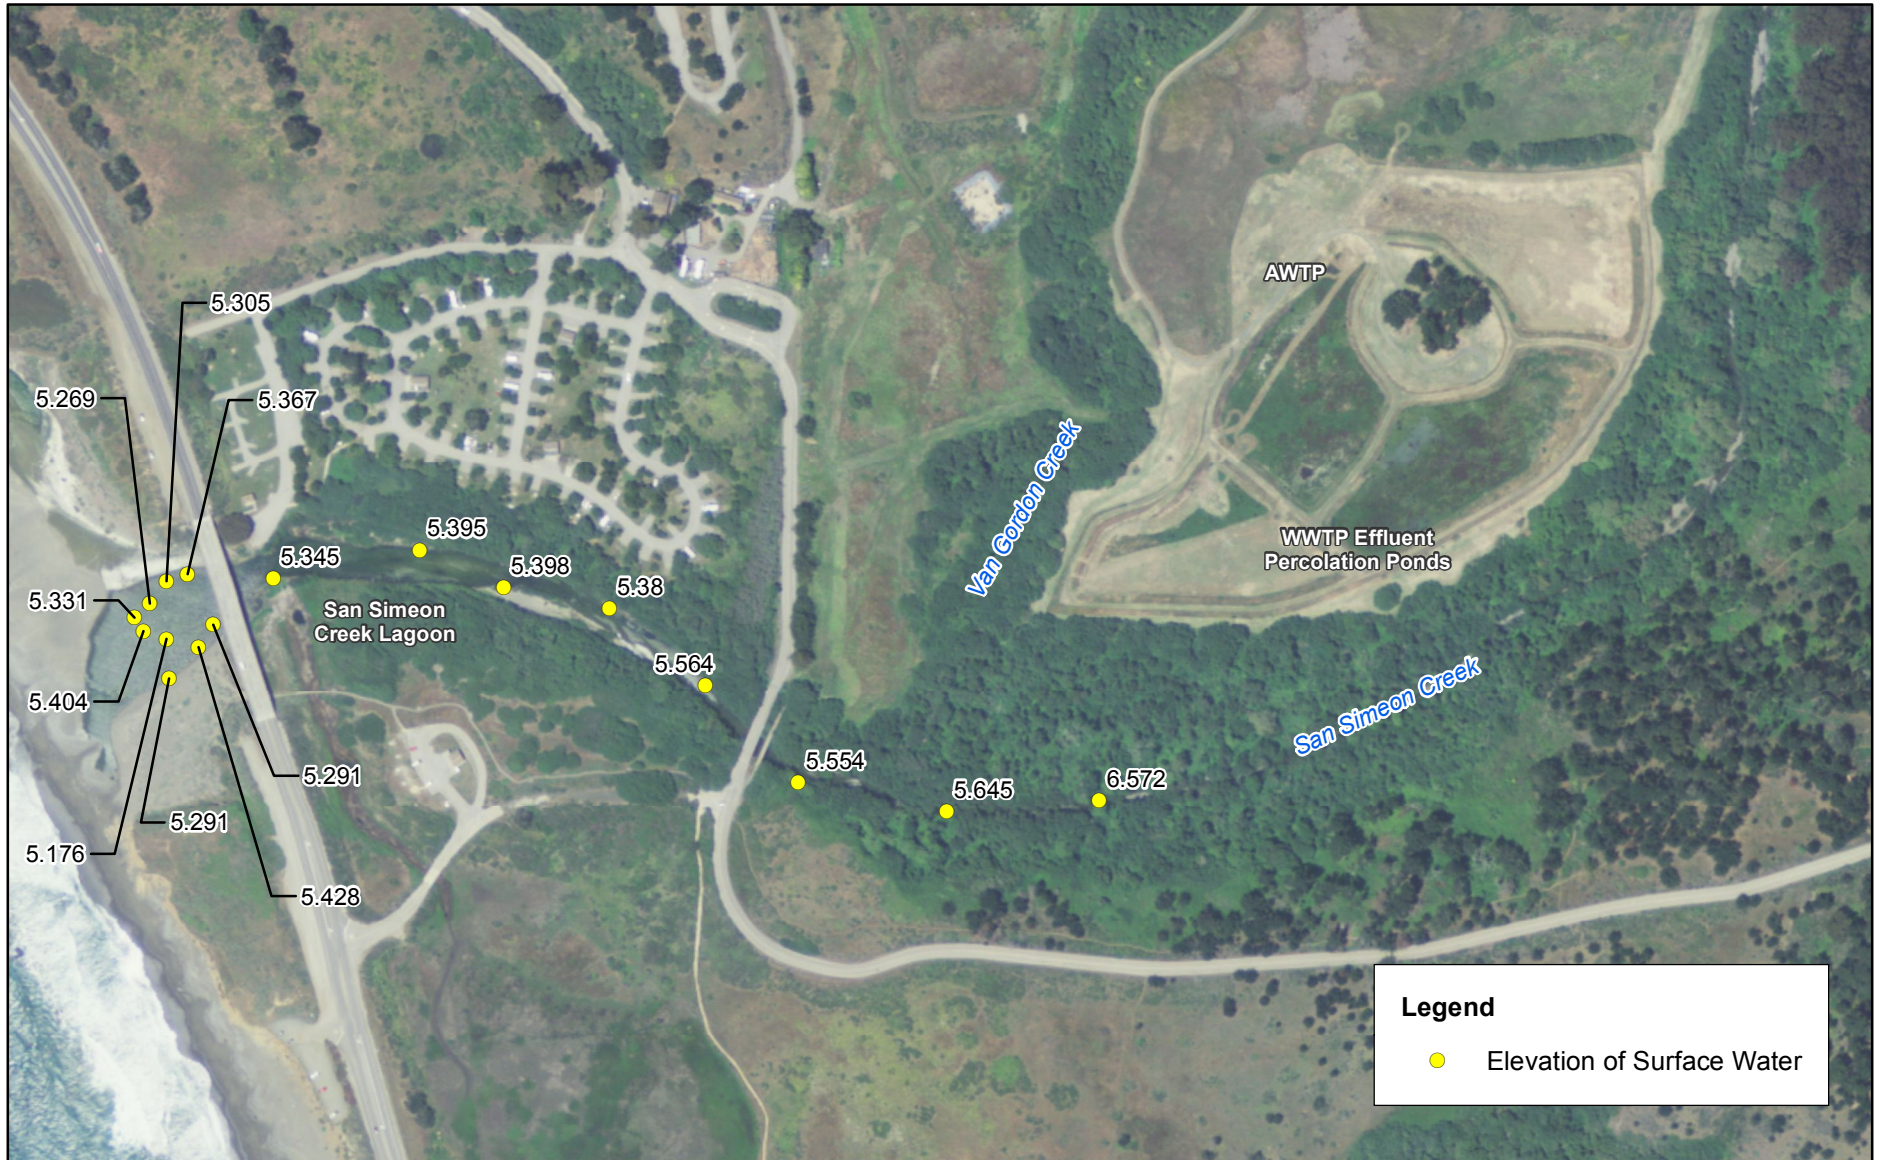
**Figure 4-1
Model Grid**

The grid was rotated to approximately parallel the trend of the San Simeon basin. Cells outside of the aquifer footprint and in deeper portions of the grid in the eastern part of the model were inactivated. **Figure 4-1** shows the extent of the model, while **Figure 4-2** shows the model grid in the area of primary concern between the CCSD well field and the wastewater percolation ponds.

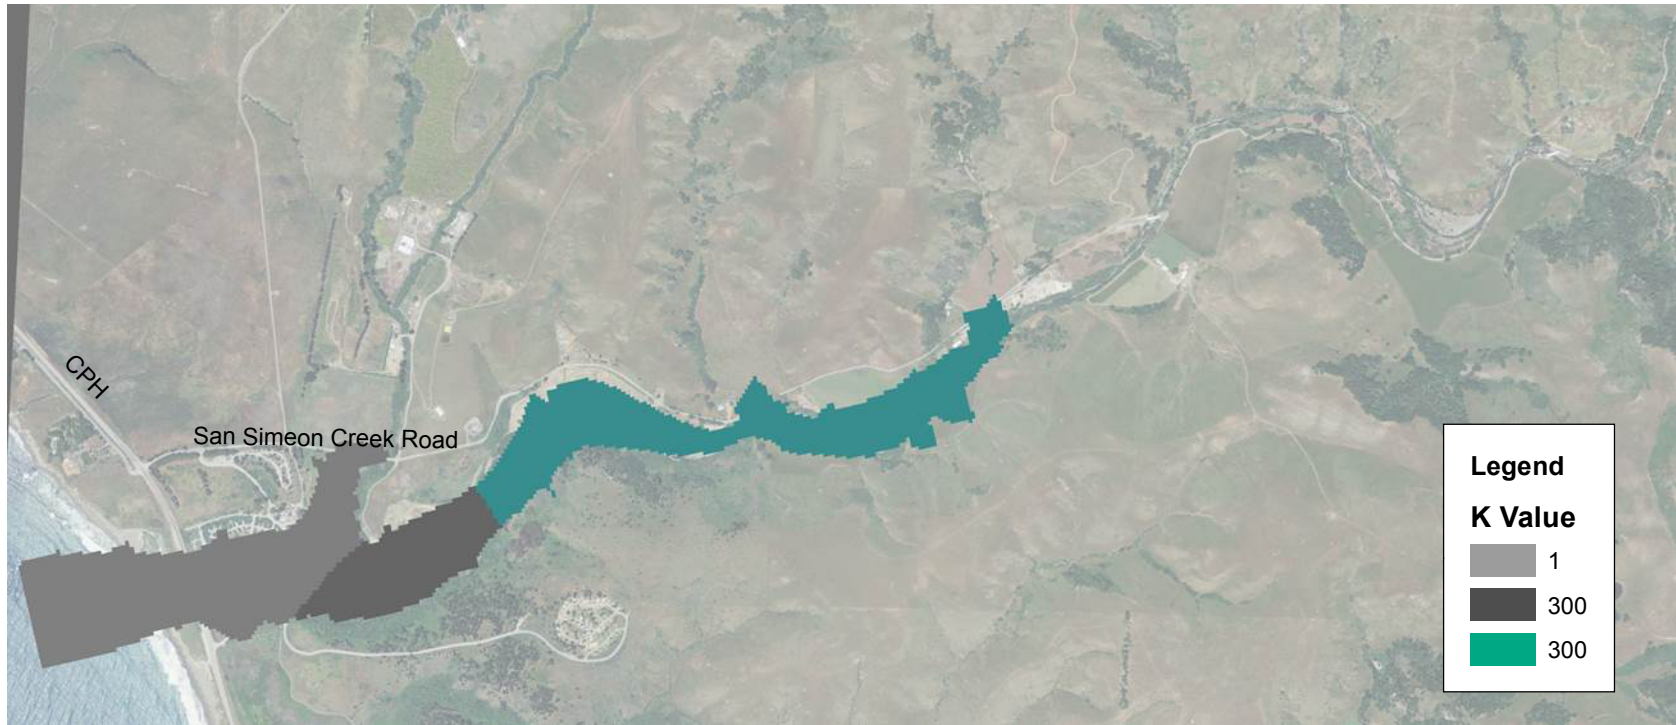
Figure 4-4
Middle Zone Hydraulic Conductivity Distribution

Figure 4-3, thru **Figure 4-5** show the distribution of horizontal hydraulic conductivity for the upper, middle and deep zones respectively. The distribution of hydraulic conductivity incorporates the conceptual model characteristic of a lower permeability zone in shallow materials in the western extent of the model down-gradient of the confluence of Van Gordon Creek. A constant ratio of horizontal to vertical hydraulic conductivity of 10:1 was used throughout the model domain. The initial specific yield was set to 0.12, with changes that were incorporated during calibration described in subsequent sections.

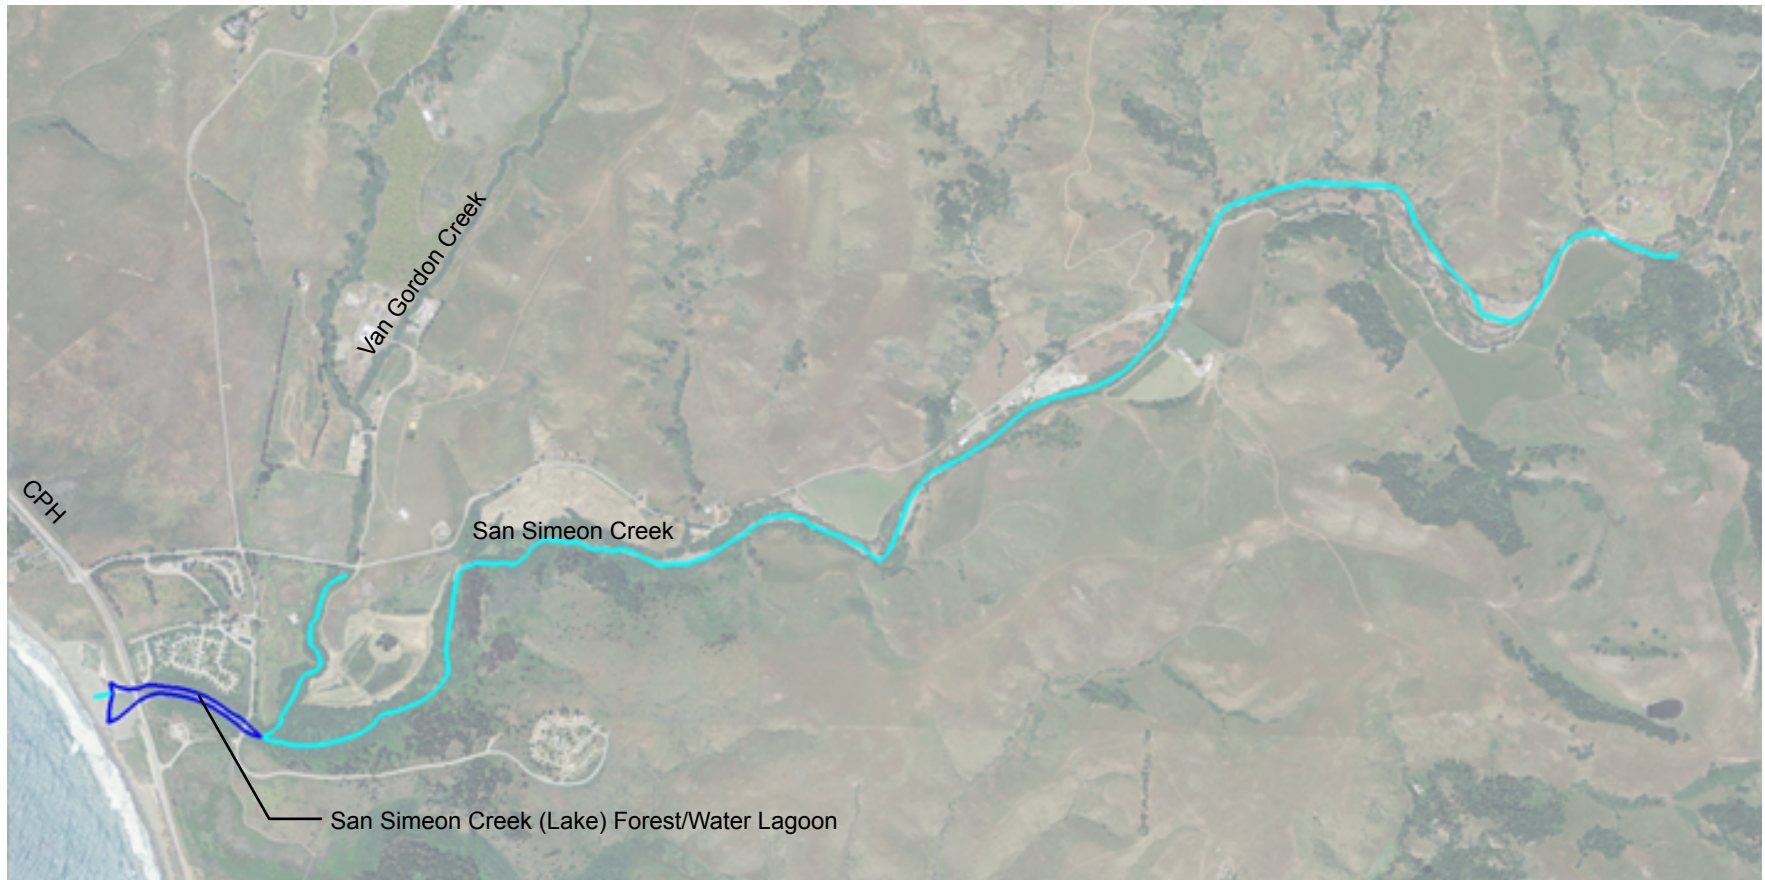
Figure 4-8
Location of Stream and Lake Boundary Conditions

- Stream Boundary
- Lagoon Boundary

The lake package was configured to reflect a high degree of connection between the lake and groundwater. Figure 4-8 shows the location of the fresh water lagoon and associated streams. An outlet stream was used to simulate conditions when the lagoon discharges to the ocean. The water surface and lagoon bottom was surveyed to obtain accurate location and elevation information. No data were available to allow calibration of leakage parameters for the lagoon. During transport and variable density simulations the stream package was used to represent this feature to maintain compatibility with the model codes.

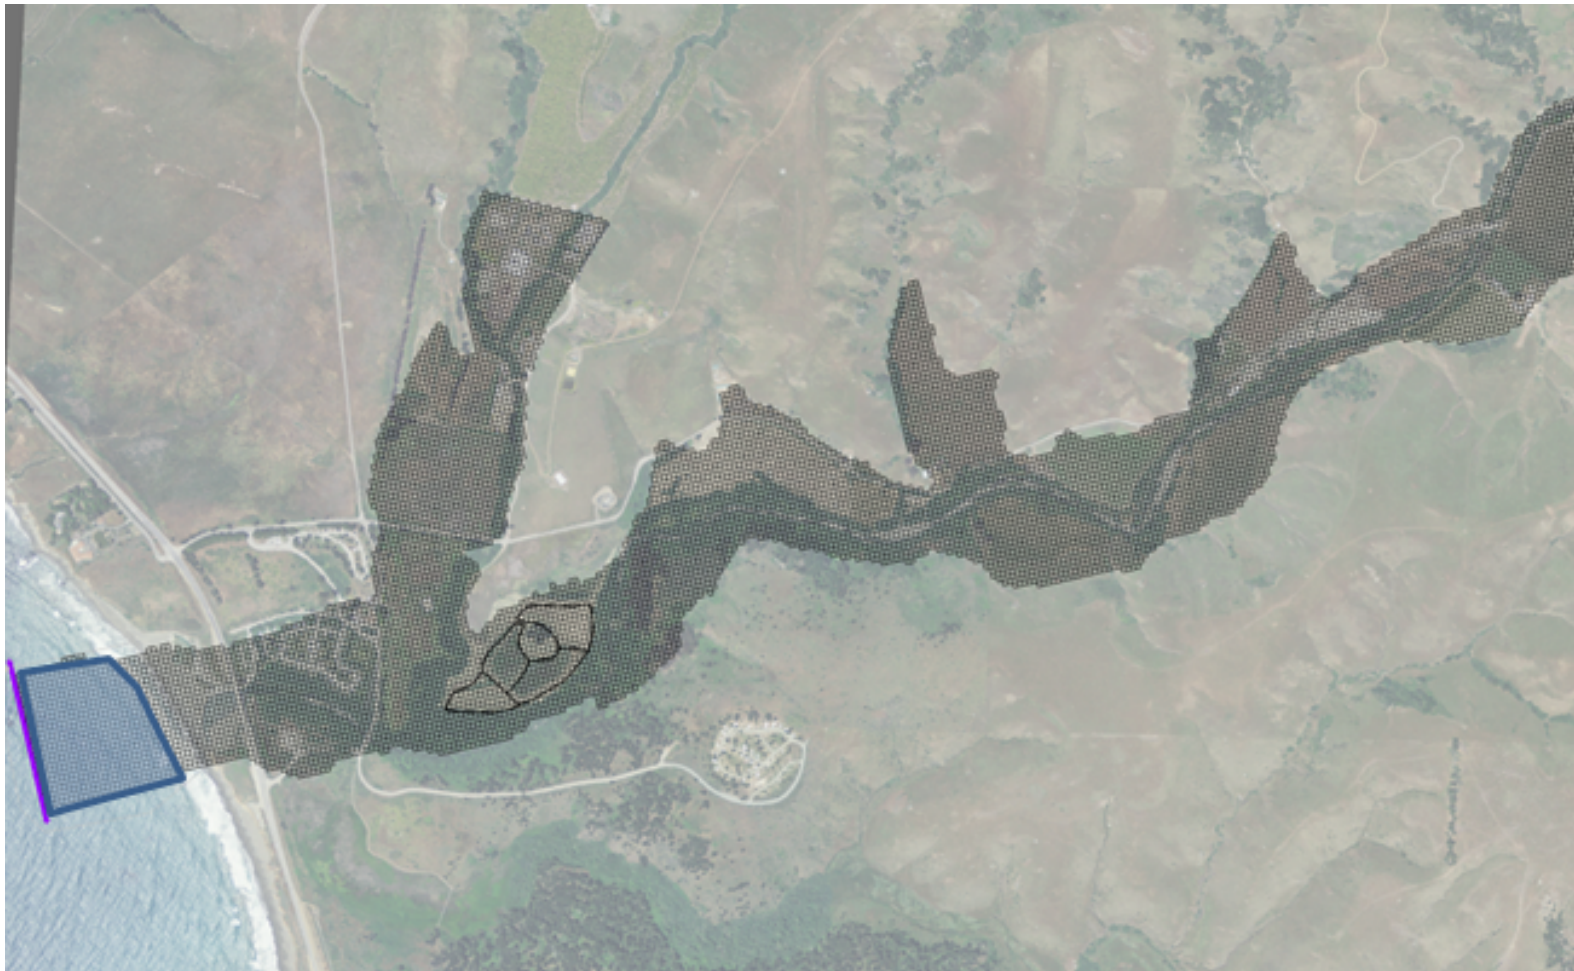
Figure 4-9
Location of Constant Head Boundary Conditions

- Constant head deep layers
- Constant head layer 1

The hydraulic connection with the ocean is simulated using constant head boundary conditions in the off-shore area. The boundary associated with the ocean was simulated using the equivalent fresh

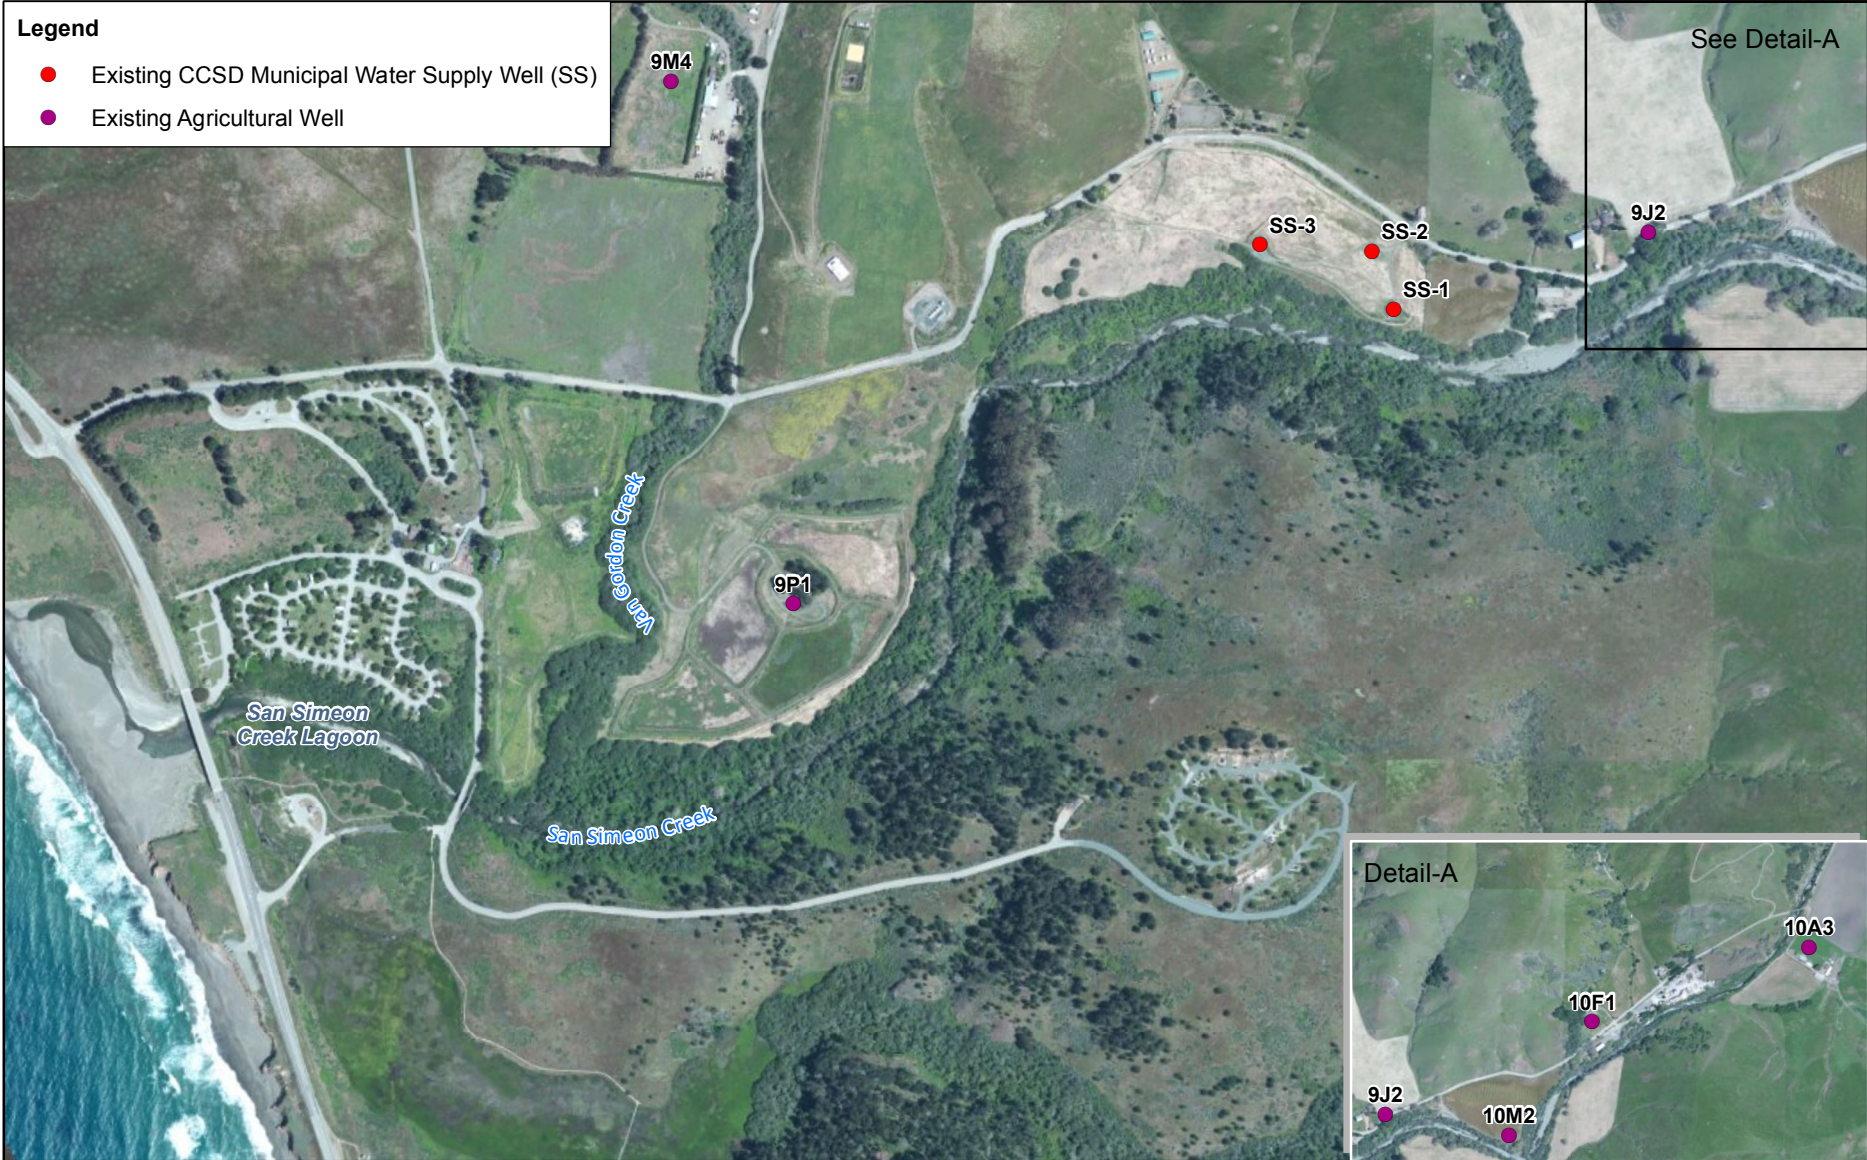
**Figure 4-10
Location of Pumping Wells**

Estimates of agricultural pumping were developed in the 2007 study based on land use and water user interviews (Yates, 2007). Production records from CCSD were used for the municipal pumping rates. **Figure 4-10** shows the location of pumping wells that were included in the model. Total agricultural pumping occurs during the growing season from June through October, with an average of 180 AF per year of groundwater produced. The CCSD production from the San Simeon basin is limited to 454 gpm (0.635 MGD) during the dry season. The recent pumping was previously presented on Figure 2-11. Well 9P7, located in the percolation pond area, is periodically pumped to maintain a seaward gradient from the well field. However, detailed records of pumping from this well are not available.

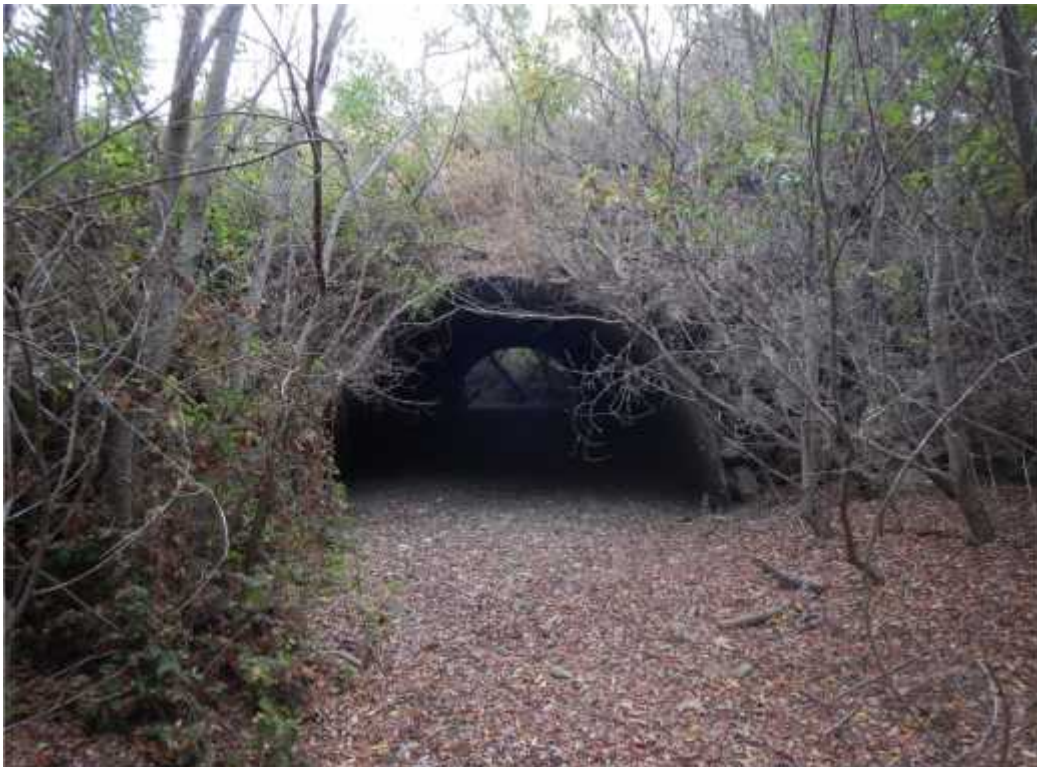
Photograph 18 – View looking northeast of 15' corrugated metal pipe culvert and Van Gordon Creek in the northern portion of project site.

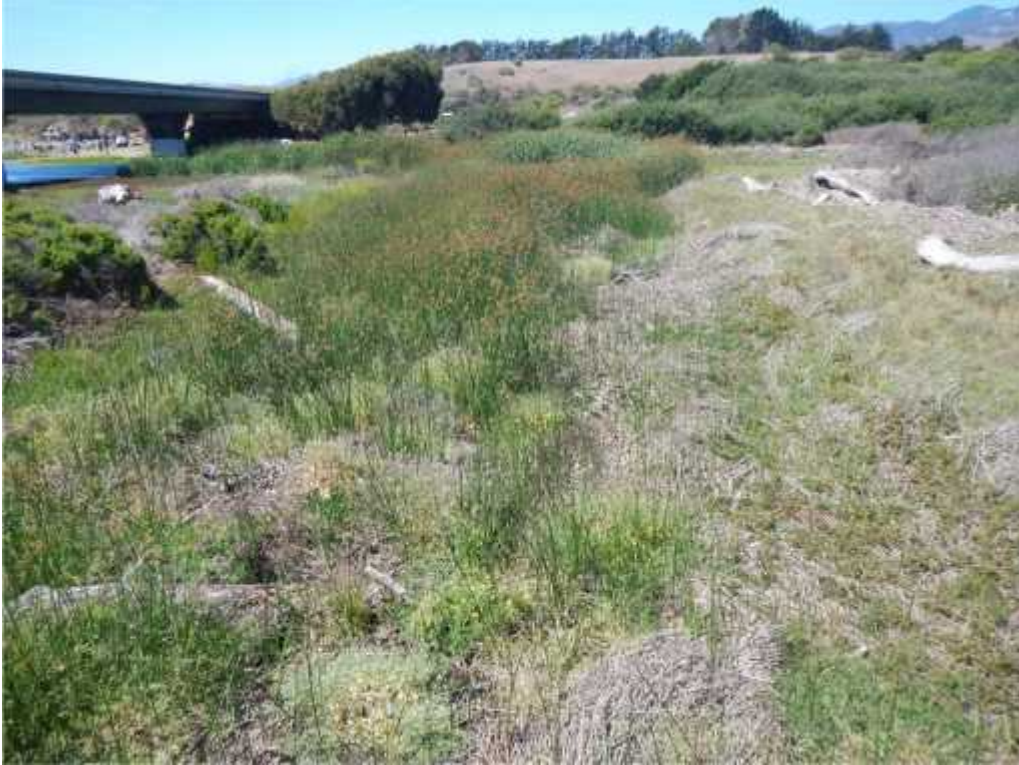
Photograph 25 – View looking northeast of Wetland 3 in the western portion of the project site.

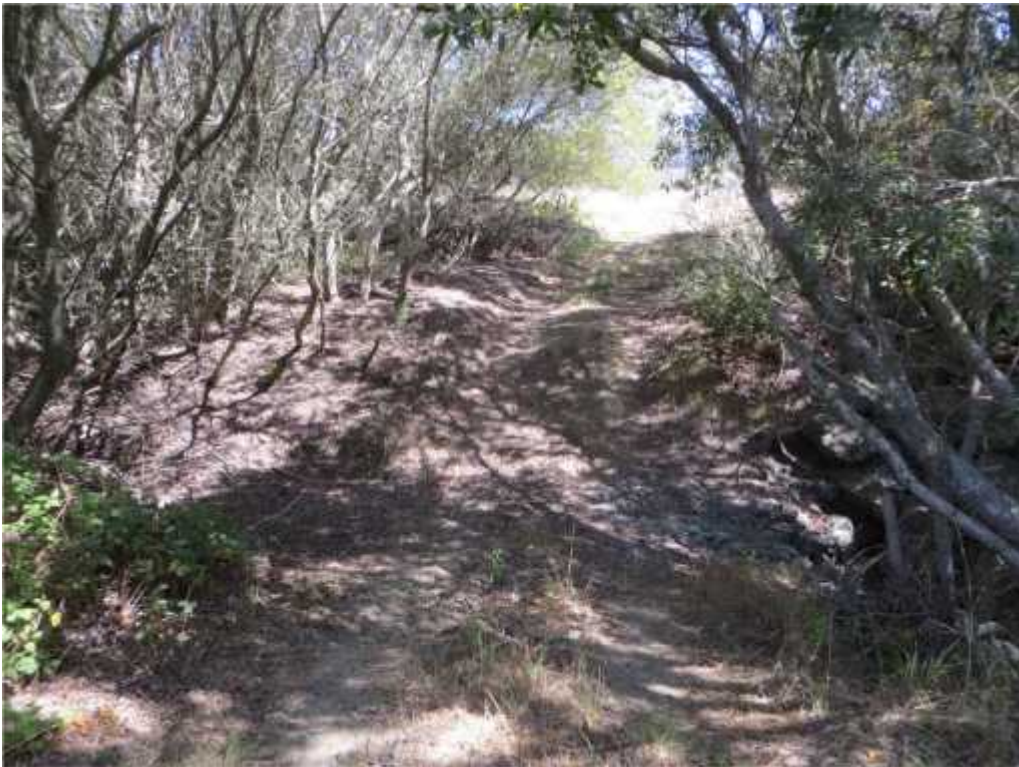
Photograph 26 – View looking east of temporary trenching corridor across Van Gordon Creek.

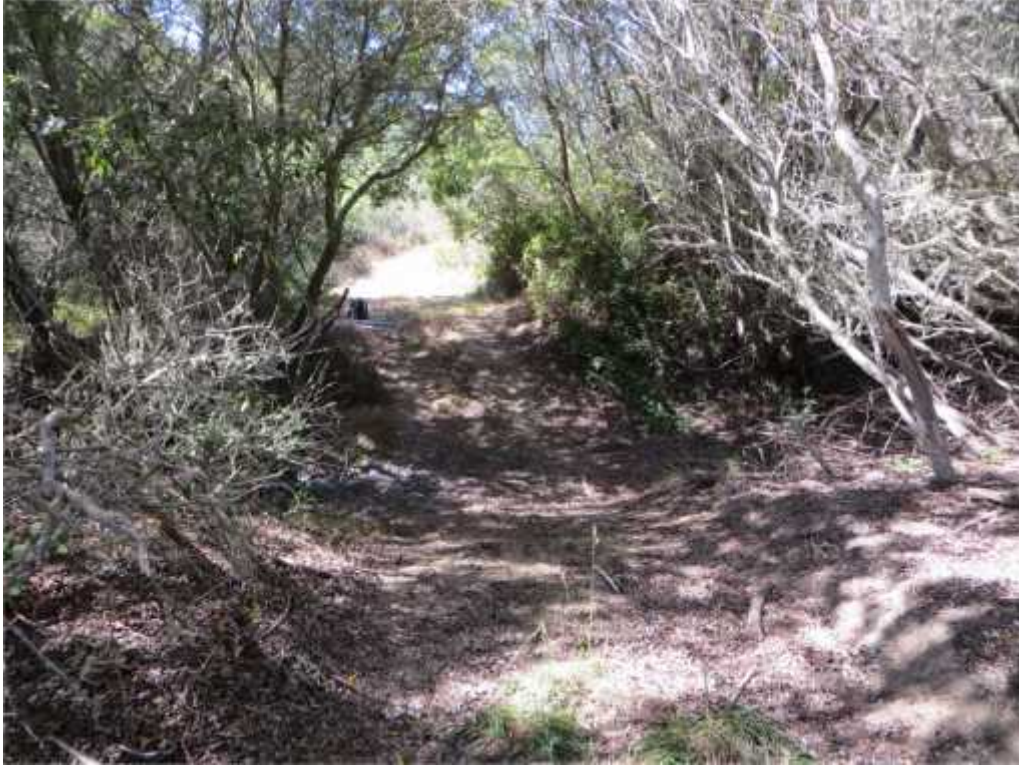
Photograph 27 – View looking west of temporary trenching corridor across Van Gordon Creek.

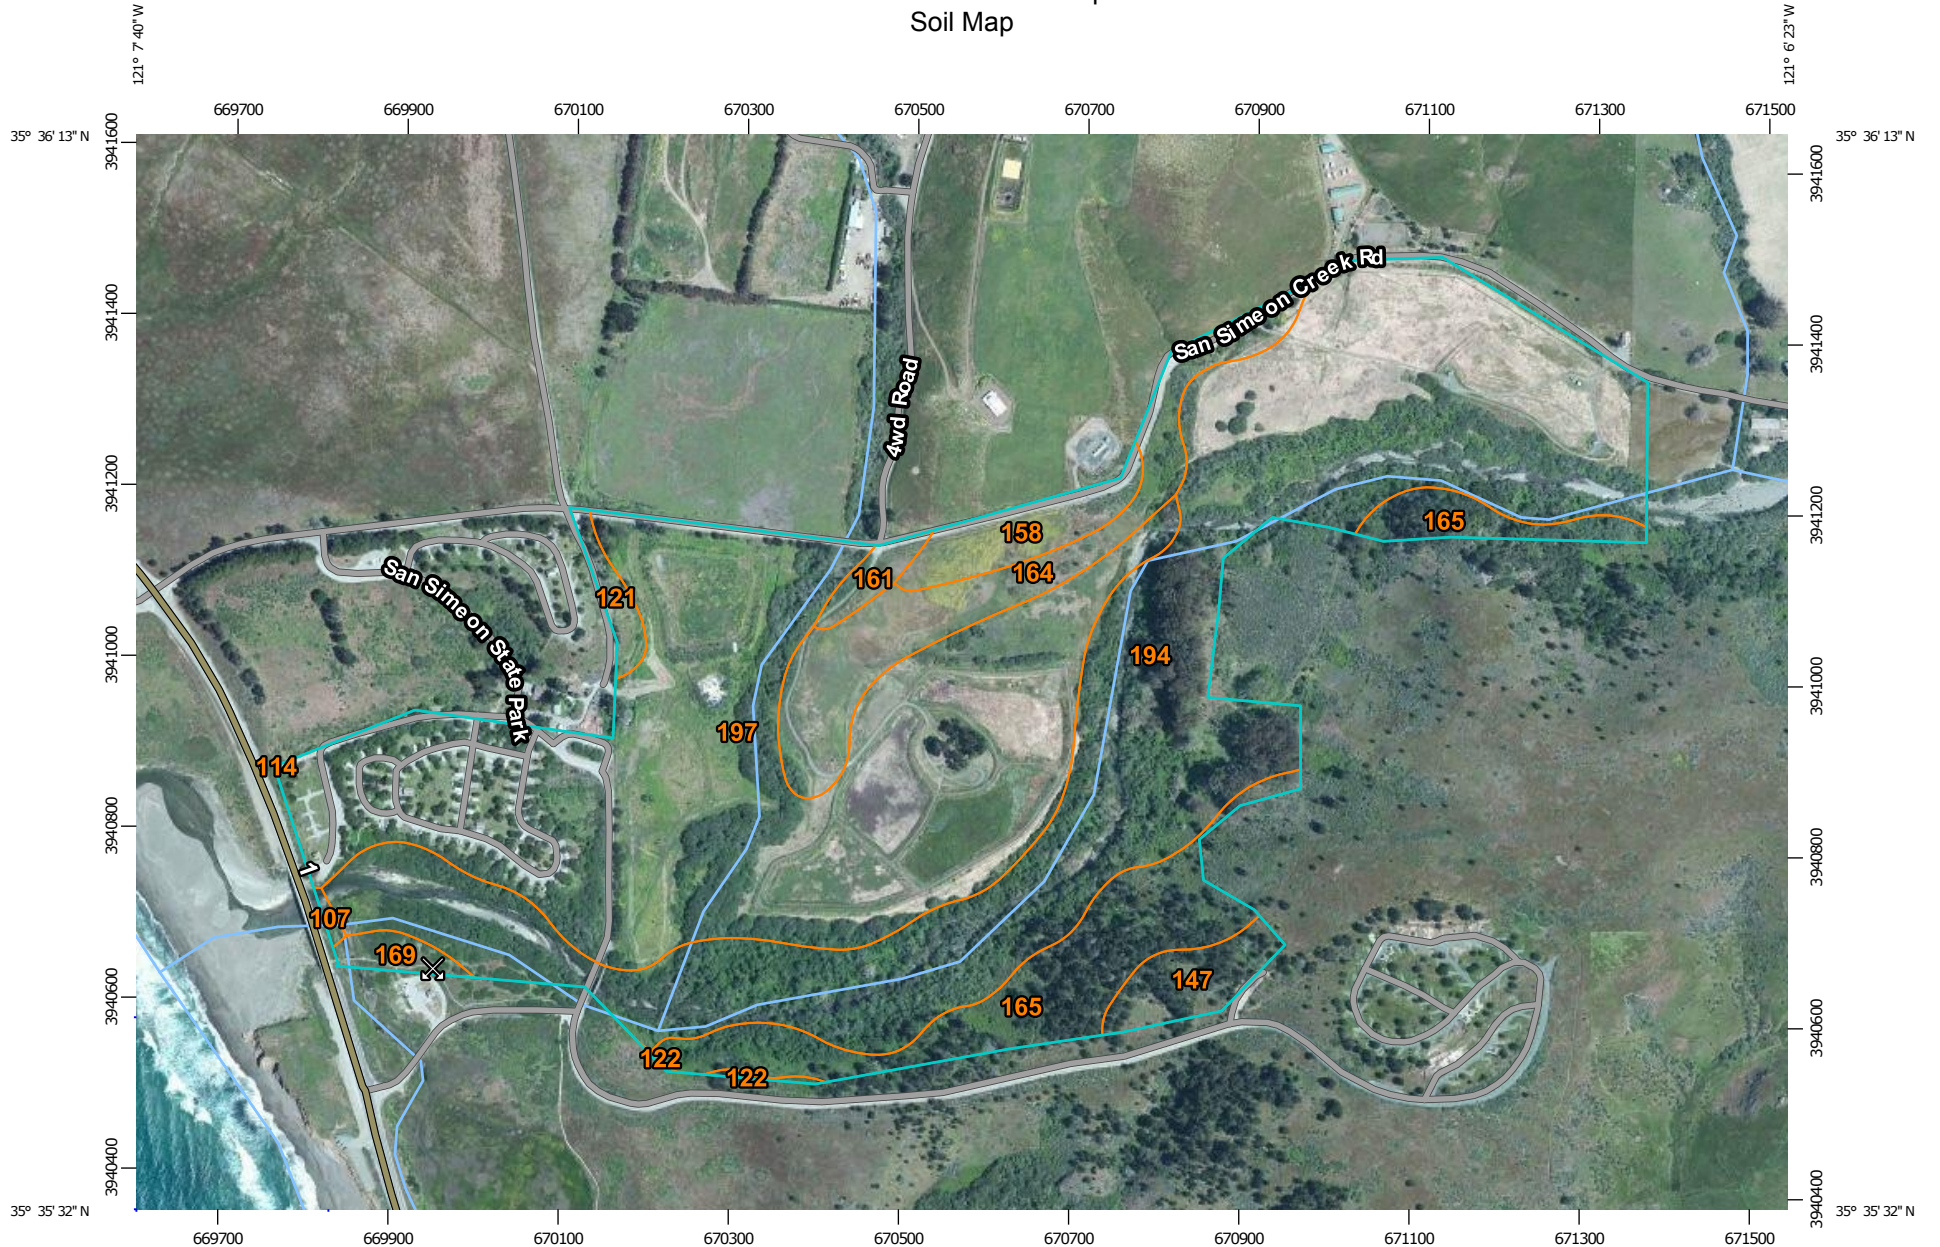
Custom Soil Resource Report Soil Map

The soil map section includes the soil map for the defined area of interest, a list of soil map units on the map and extent of each map unit, and cartographic symbols displayed on the map. Also presented are various metadata about data used to produce the map, and a description of each soil map unit.

Map Scale: 1:8,880 if printed on A landscape (11" x 8.5") sheet.

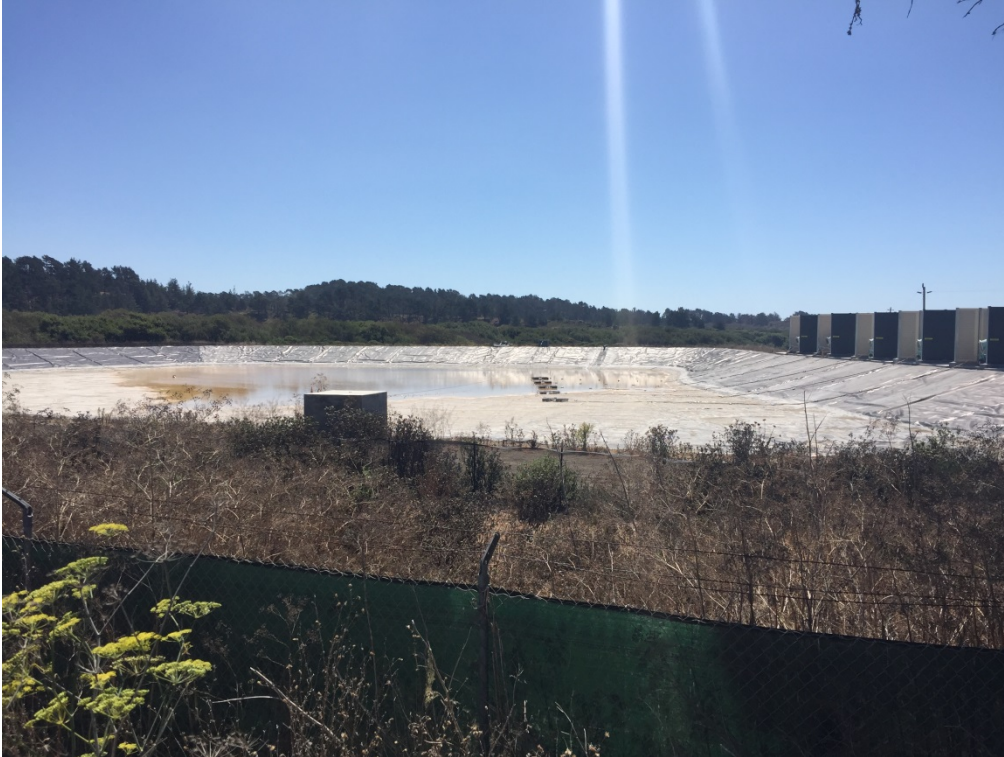
Figure 1. Evaporation pond

- The evaporation pond contained a shallow body of water covering approximately half of the pond's overall surface area (Figure 1).
- Exposed areas of the pond's dark liner that had previously had water present exhibited deposits of light colored dried material (Figure 1).

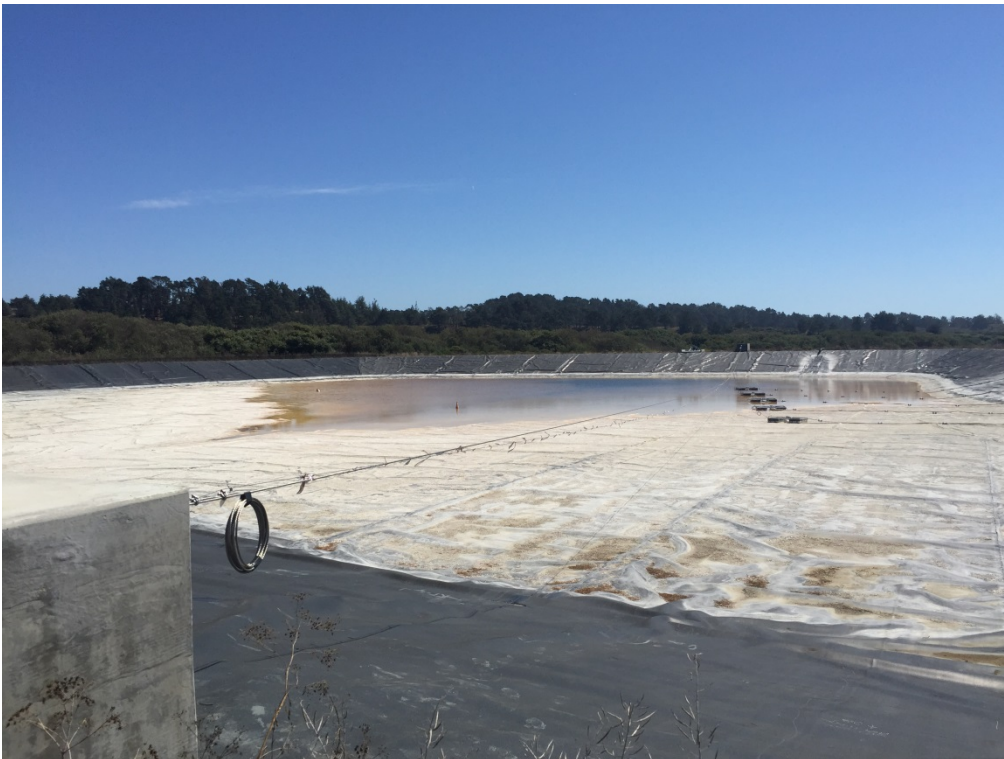
Figure 2. Evaporation pond with cable and mylar flag remnants

- A single cable that stretches across the pond had previously had mylar flagging attached to it, but that flagging had mostly been shortened to minimal lengths by deterioration in the wind (Figure 2).

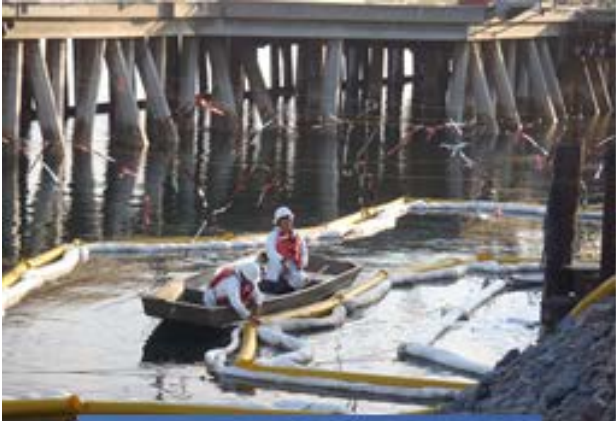
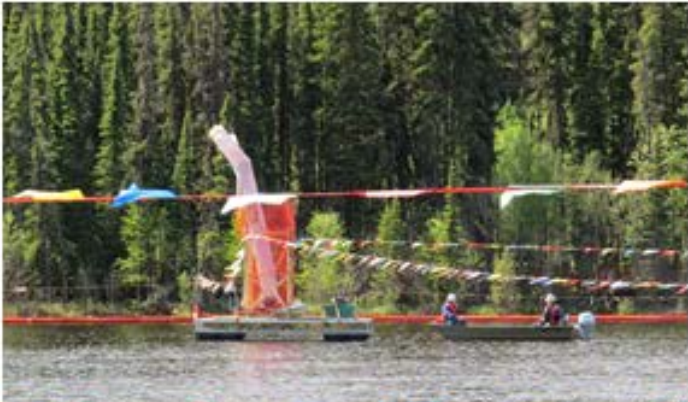
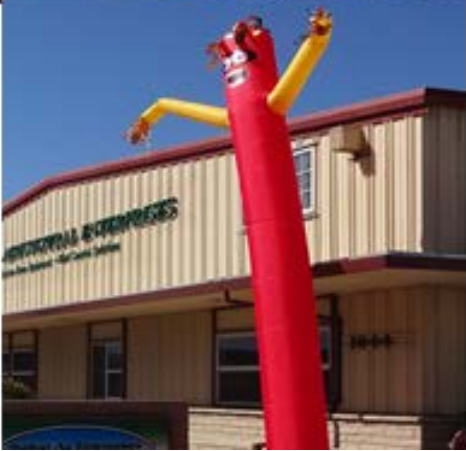
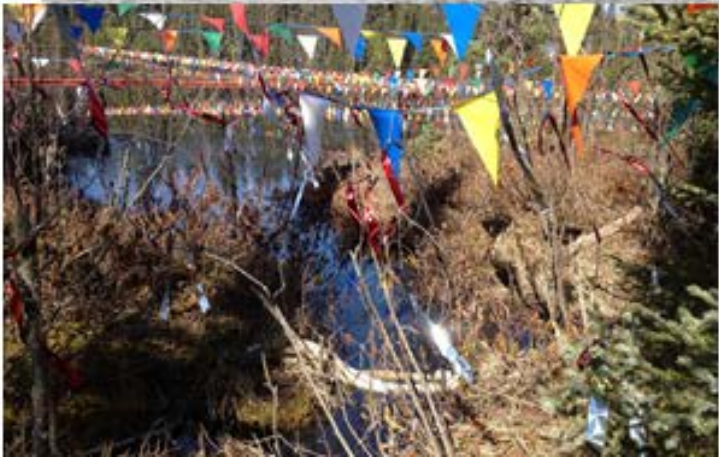
Figure 3 – Examples of flagging, mylar, and “Air Ranger” (scary man) type visual scaring devices

Possible hazing or exclusion approaches	Pros	Cons
Scary men ("Air Ranger") type on timers or constant	one of most effective visual tools	would likely require multiple units on platforms in the pond area to be adequately effective, and would require electricity at their sites, would only work for a certain period of time, should be brought in if rains
Mylar and other flagging - kites - effigies etc	Effective if extensive enough	would require large numbers of lines across the expanse of the pond and regular monitoring, materials would have to be replaced frequently, would only work for a certain period of time unless mylar is kept quite densely placed, would need lines on pullies for regular replacement, birds might

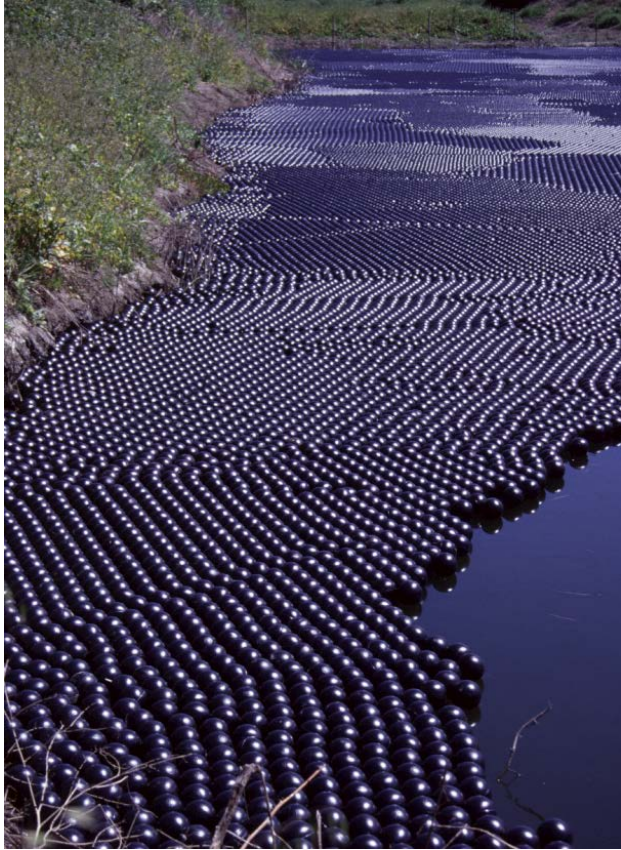
Figure 4. “Bird balls” – black floating balls

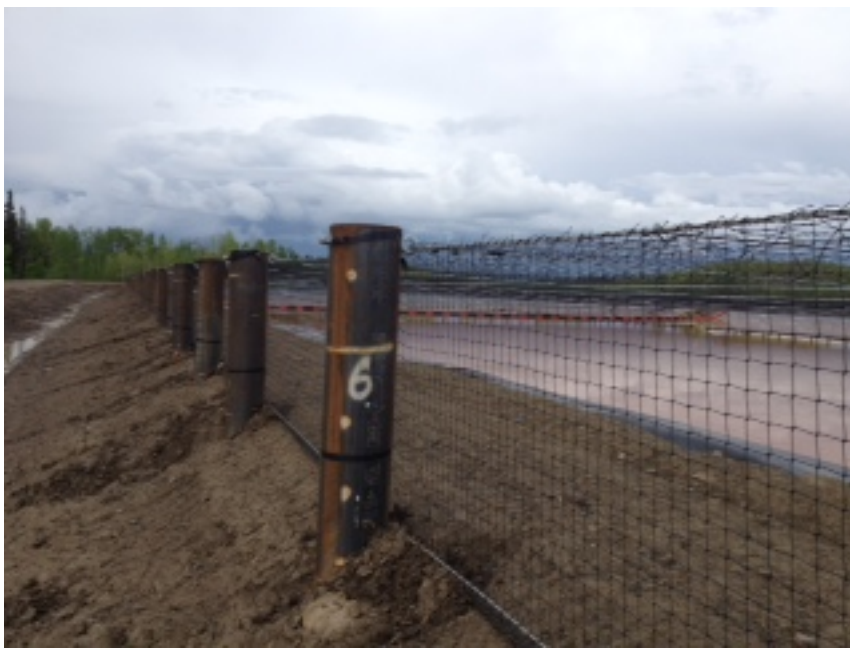
Figure 4. Netting example #1

It is Dr. Vickers' judgement that option 3 above, a combination of buried fencing and netting, affords the best likelihood of maximum wildlife restriction from the evaporative pond over long periods of time. Other options have functional shortcomings when compared to the total exclusion expected with option 3, however they could be chosen for financial reasons with acceptance of lower effectiveness.

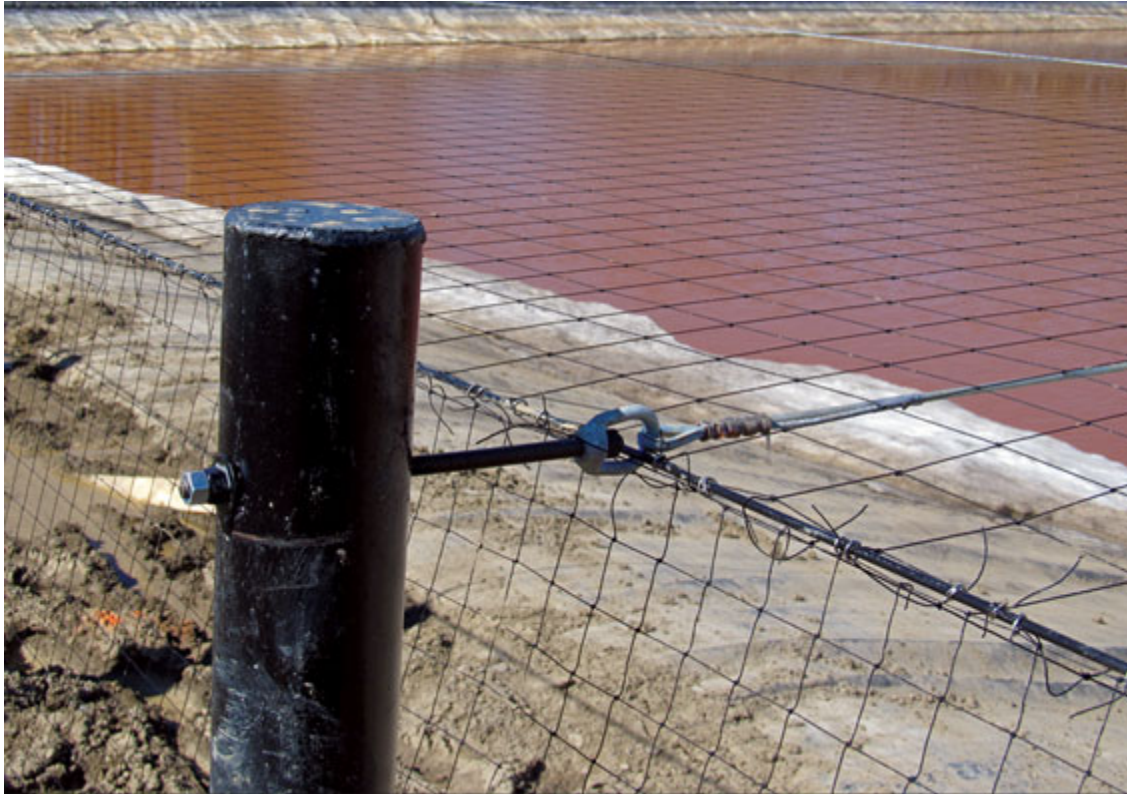
Figure 5. Netting example #2
