Appendix E1
Cambria Emergency Water Supply
Project San Simeon Creek Basin
Groundwater Modeling Report

Cambria Emergency Water
Supply Project
**San Simeon Creek Basin
Groundwater Modeling
Report**

Cambria, California
May 2014

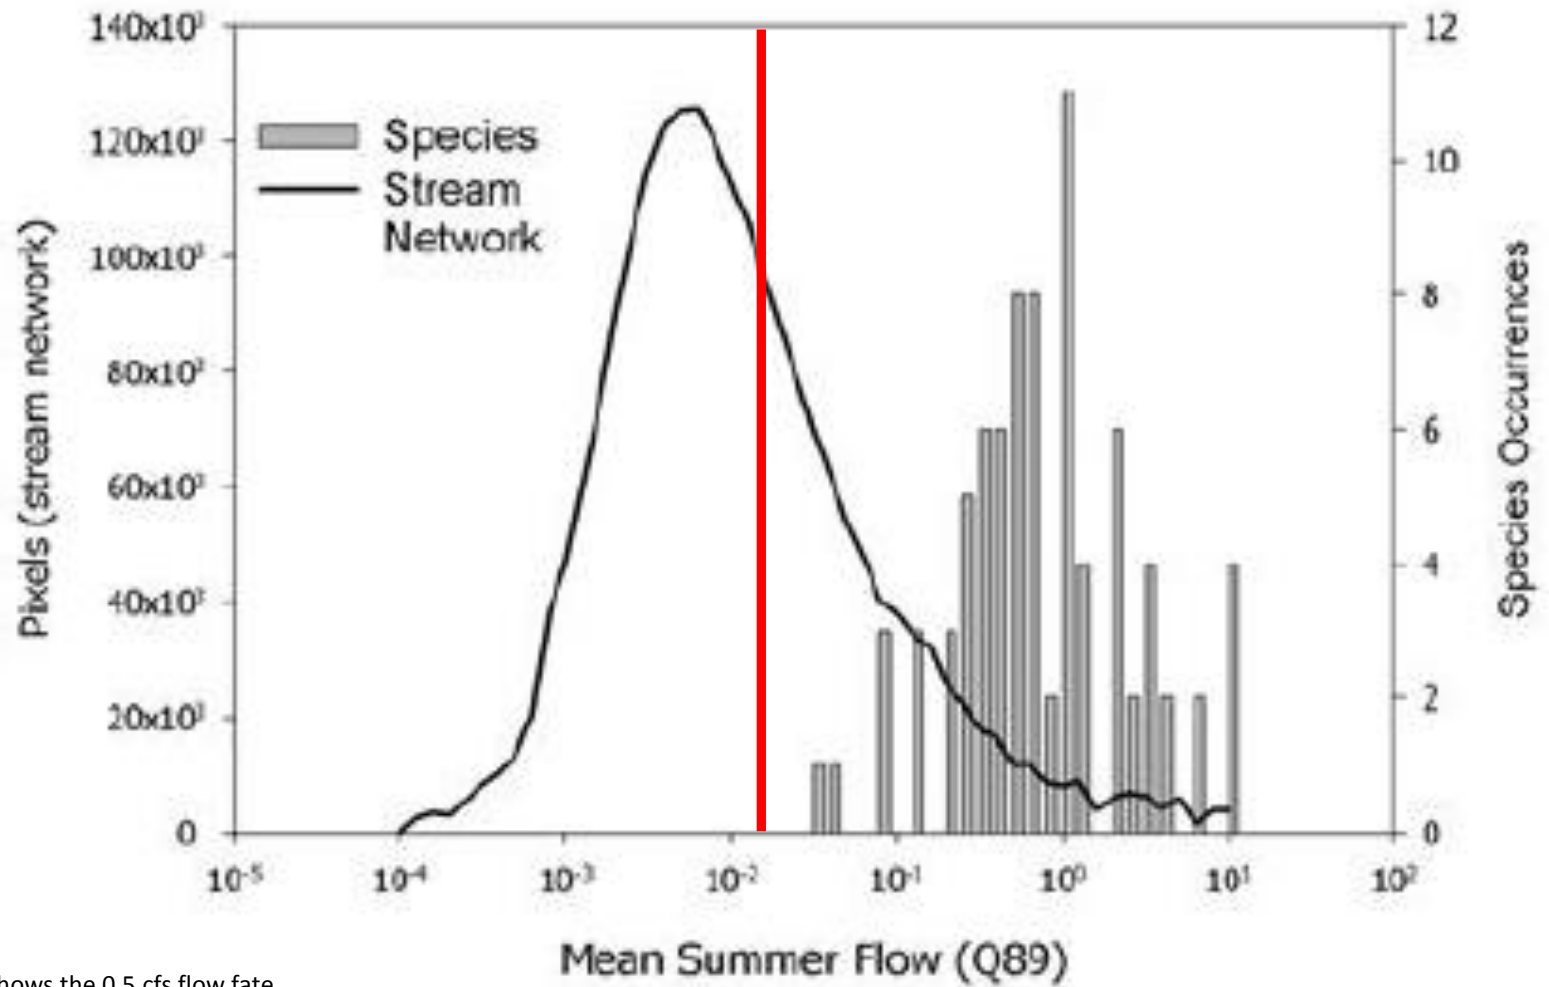
Figure 1 – Steelhead Occurrence and Mean Summer Flow (NOAA, 2006)

Note: Vertical red line shows the 0.5 cfs flow fate

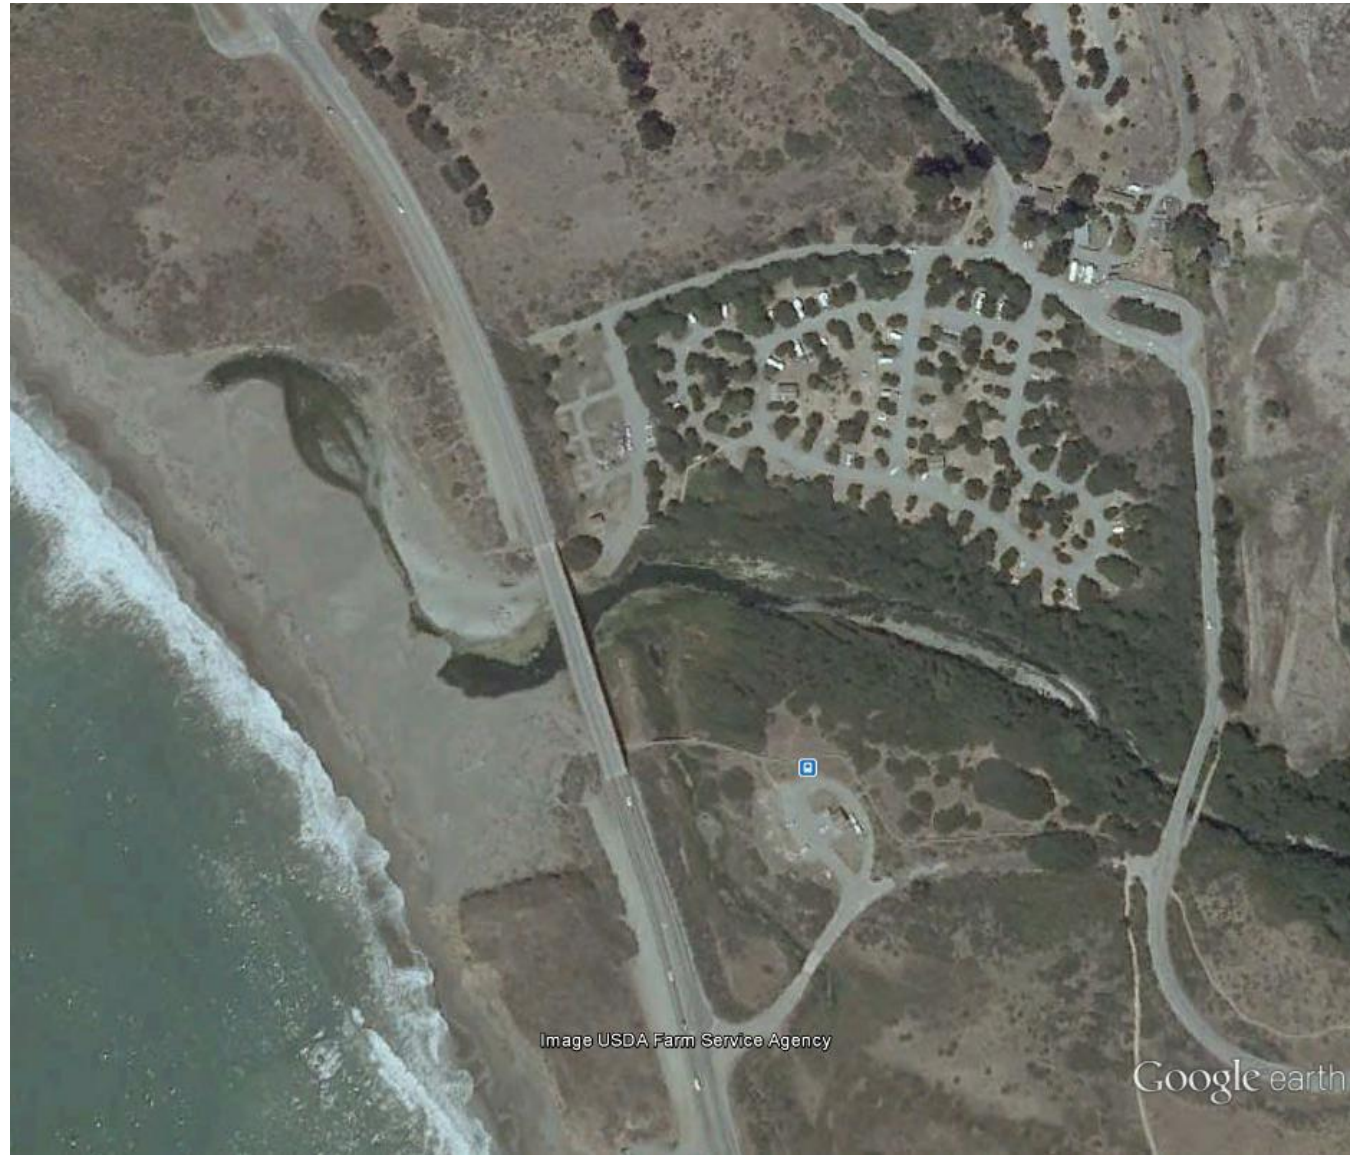
Figure 2 – March 2010 Aerial Photo Showing Discharge to Ocean

The San Simeon lagoon occurs on the beach area and upstream for a distance of up to about 2,000 feet. During periods of the year when there is little or no flow entering the area from upstream, the lagoon is isolated from the ocean by a beach berm that develops due to wave action. This beach berm can be breached temporarily during the dry season by high waves, when seawater can enter the lagoon. During periods when surface water flows exceed seepage and evaporation rates, water may discharge to the ocean when the water level in the lagoon rises sufficiently to breach the beach berm. This surface water flow occurs during the rainy season, which typically occurs between December and April. Figure 2 shows an aerial photograph of this condition in March 2010, when flows observed in San Simeon Creek averaged 226 cfs at the Lower San Simeon gage. After surface water flow in San Simeon creek ceases during the dry season, the beach berm is re-established by wave action and discharge to the ocean ceases. Figure 3 is an aerial photograph showing this condition in September 2010, where a lack in flow in the creek has allowed development of a berm
