## A. GEOLOGY AND SOILS

This section was prepared by Cleath and Associates, and includes an analysis of geologic and soils hazards including landslides and slope stability; seismic induced landslides and rock falls, fault displacement, ground shaking and liquefaction; mineral hazards; and expansive soils. Published geologic reports, aerial photographs, the *Soil Survey of San Luis Obispo County (Coastal Part)*, and bluff retreat studies were reviewed prior to assessing these hazards. A geologic site reconnaissance was conducted, the distance to known faults was determined, and the information regarding the geologic subgrade were all used to evaluate seismic hazards.

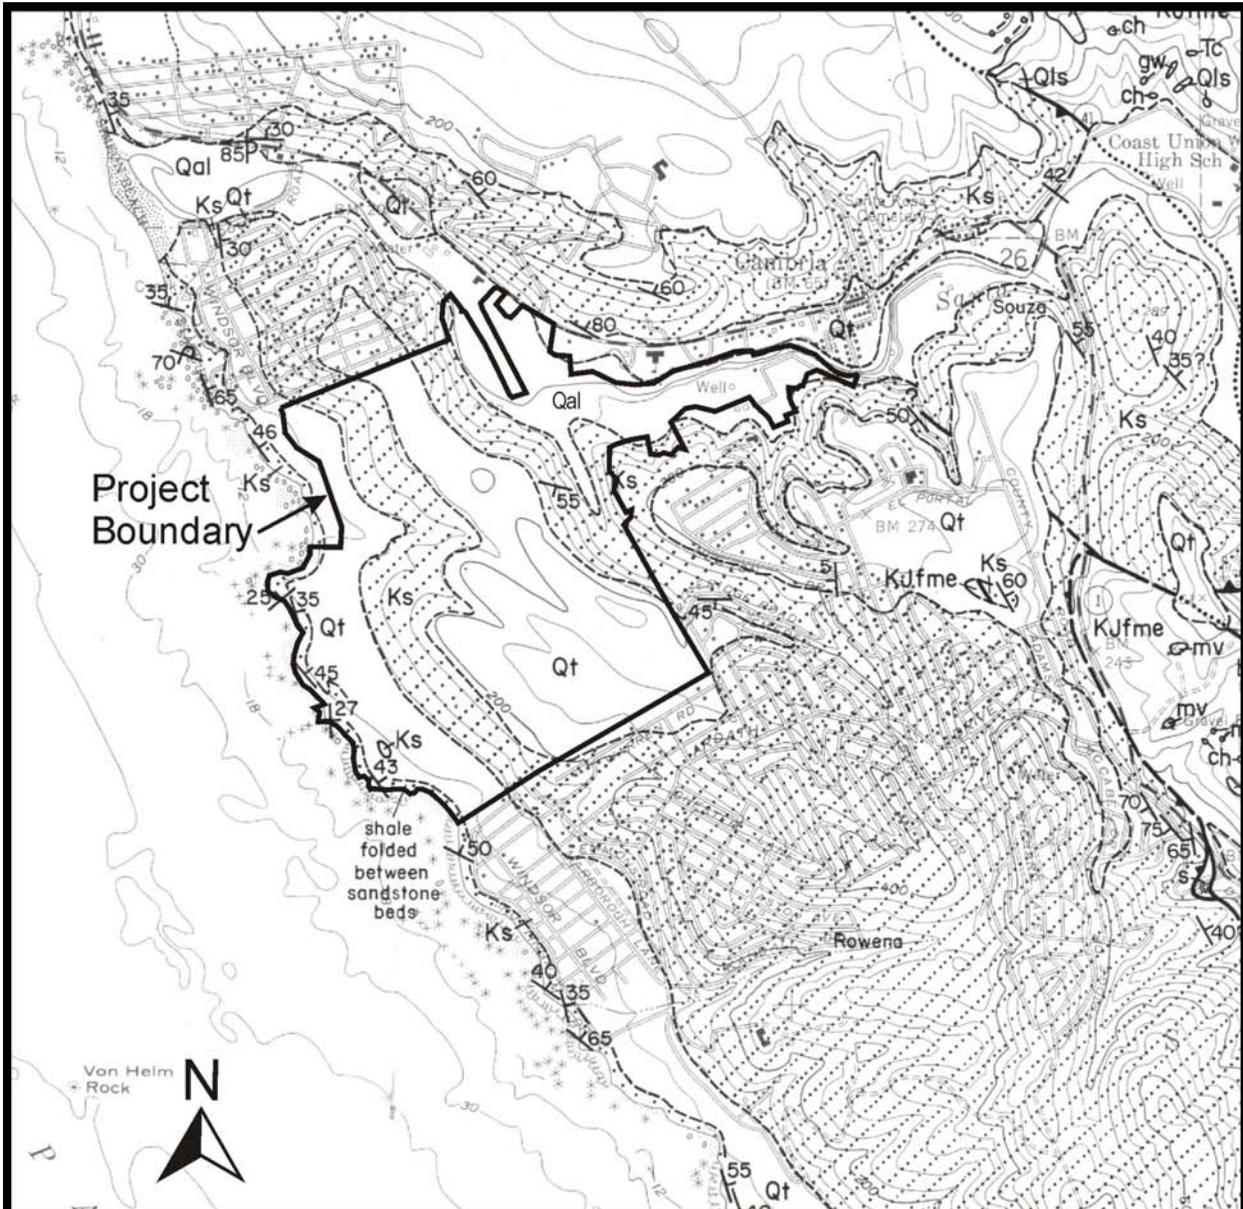
Regional Geology Map  
FIGURE V-2

Base Map: Geologic Map of the Cambria Region,  
San Luis Obispo County, California, Hall, C.A. 1974  
Scale: 1 inch = 2,000 feet

Exposed bedrock in the West FRP area consists of the Franciscan melange and the Cretaceous sandstone. The Franciscan melange is a pervasively sheared mixture of sandstone, chert, serpentine, basalt, and greenstone, with blocks of high grade metamorphic rocks, all set in a sheared claystone-siltstone matrix. The melange is exposed only in a few places at the base of the coastal bluff, whereas the Cretaceous sandstone is the predominant bedrock unit exposed along the bluff. The Cretaceous sandstone is also found either exposed or beneath thin pedogenic soils along the steeper, upland portions of the West FRP. The Cretaceous sandstone unit is of marine origin and consists mostly of moderate to well cemented arkosic sandstone, and lesser weakly resistant interbedded shale. The sandstone and shale beds are folded and generally dip to the northeast into the bluff at 27 to 45 degrees.

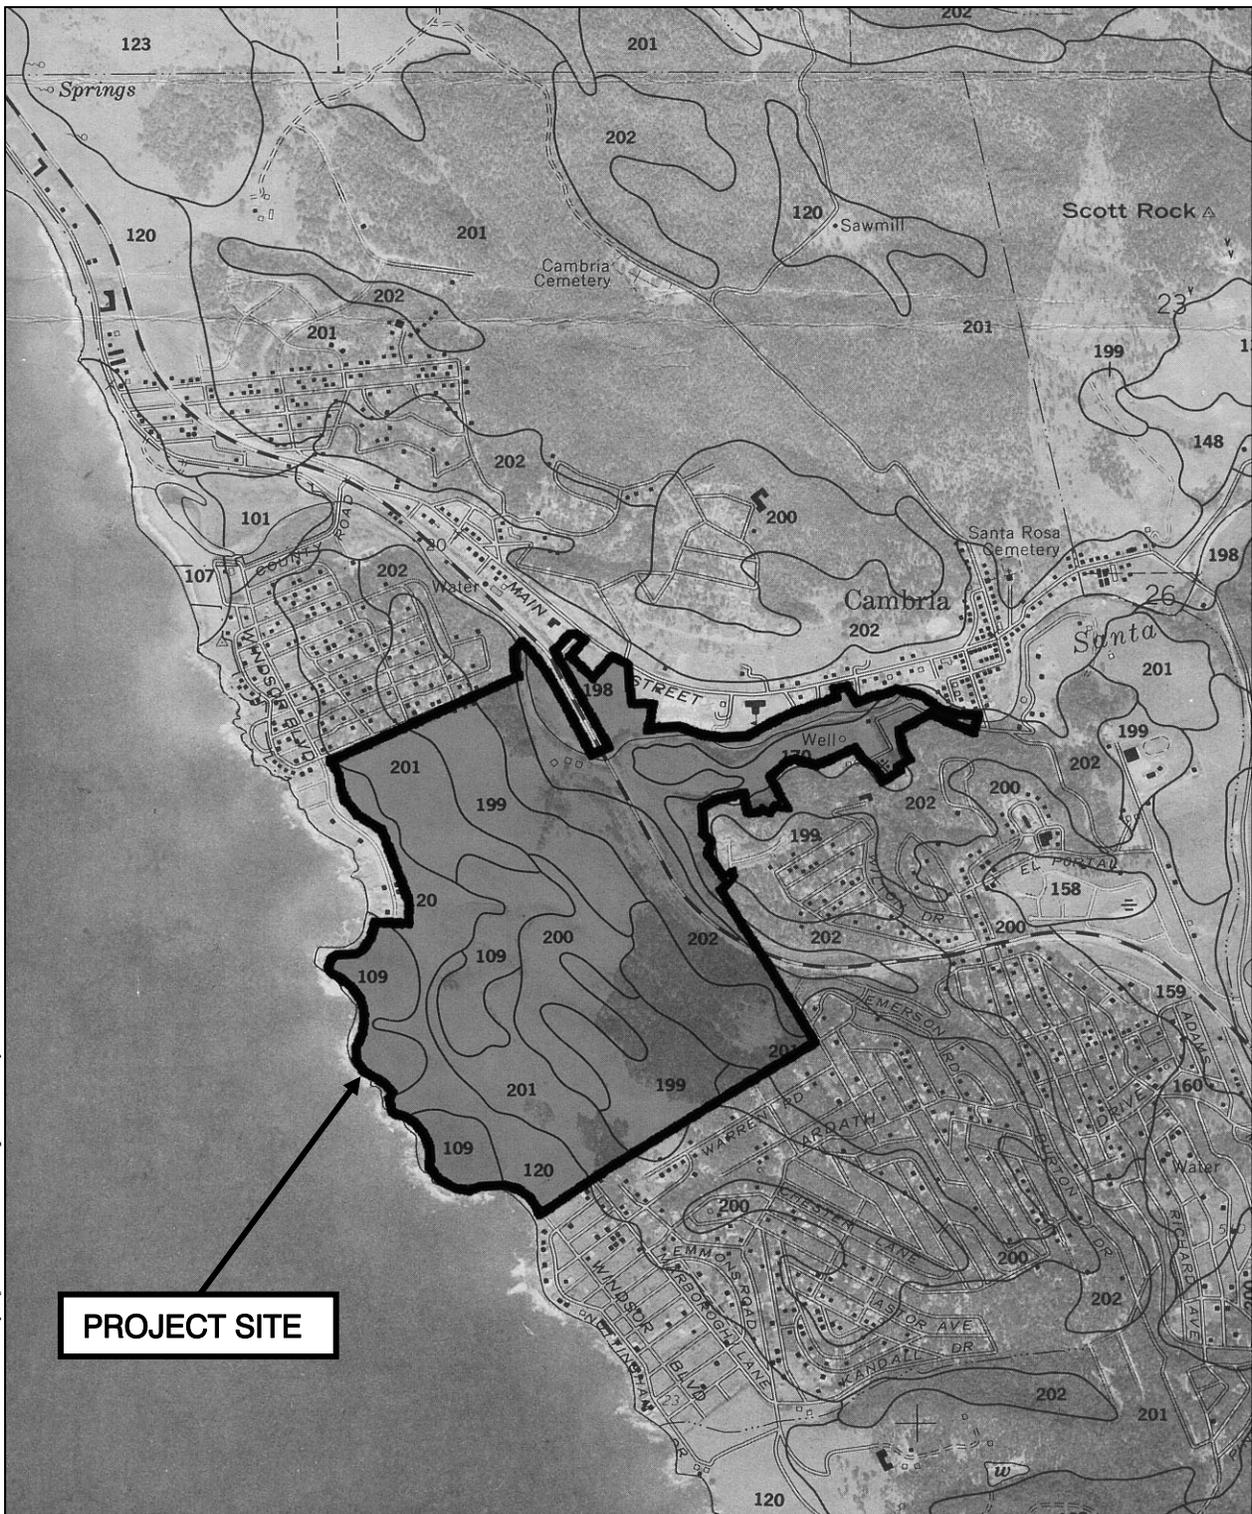
Source: Soil Survey of San Luis Obispo County, Coastal Part – Sheet 4

**SOIL KEY**

- 109** Briones-Pismo loamy sands, 9 to 30% slopes
- 120** Concepcion loam, 2 to 5% slopes
- 170** Marimel silty clay loam, drained
- 198** Salinas silty clay loam, 2 to 9% slopes
- 199** San Simeon sandy loam, 2 to 9% slopes
- 200** San Simeon sandy loam, 9 to 15% slopes
- 201** San Simeon sandy loam, 15 to 30% slopes
- 202** San Simeon sandy loam, 30 to 50% slopes

- *Briones-Pismo loamy sands (109)* are found on the moderate slopes along most of the coastal bluffs and inland of the coast about 1,000 to 2,000 feet. These are shallow to moderately deep, somewhat excessively drained, and rapidly permeable soils that formed in residual material weathered from soft sandstone. The hazard of water erosion is moderate or high, and the hazard of soil blowing is high.

- *Concepcion loam (120)* is found in the gentle slopes above the bluff and several hundred feet inland of the bluff. It is generally very deep, moderately well drained, very slow permeable soil formed in old alluvium weathered from sedimentary rocks. The hazard from water erosion is slight. Because of the high clay content, the soil has a high shrink-swell potential in the subsoil.

- *San Simeon sandy loam (201)* is found in the steeper sloping areas between the coastal terrace and the upland areas of the site, and in the moderately to steeply sloping upland areas in the southeast corner of the site. The soil is moderately deep, moderately well drained, and the permeability is very slow. It formed in residual material weathered from sandstone. Surface runoff is rapid, and the hazard of water erosion is high. The shrink-swell potential of the subsoil is high.

- *San Simeon sandy loam (200)* is located in the slightly upland areas of the site in areas of gentle to moderate slopes. The soil is moderately deep, moderately well drained, and the permeability is very slow. It formed in residual material weathered from sandstone. Surface runoff is medium, and the hazard of water erosion is moderate. The shrink-swell potential of the subsoil is high.

- *San Simeon sandy loam (199)* is located in the upland, gently sloping areas of the site. The soil is moderately deep, moderately well drained, and the permeability is very slow. It formed in residual material weathered from sandstone. Surface runoff is slow or medium, and the hazard of water erosion is slight or moderate. The shrink-swell potential of the subsoil is high. There is a stand of Monterey pines on this soil in the southeast portion of the site, and because of the limited rooting depth between twenty and forty inches, wind damage to trees can be a problem on exposed locations.

- *San Simeon sandy loam (202)* is found in the steeply northeast sloping portions of the site. The area extends from the north to the southeast corner, in the vicinity of Highway 1. The soil is moderately deep, moderately well drained, and the permeability is very slow. It formed in residual material weathered from sandstone. Surface runoff is rapid, and the hazard of water erosion is high. The shrink-swell potential of the subsoil is high. Because of the loamy surface layer and clayey subsoil, this soil is subject to gully erosion. The soil is mostly covered with Monterey pine and understory vegetation. Because of the limited rooting depth between twenty and forty inches, wind damage to trees can be a problem on exposed locations.

- *Salinas silty clay loam (198)* is found in the gently to moderately sloping northeast corner of the site. Highway 1 crosses over this soil. The soil is very deep, well drained, and the permeability is moderately slow. It formed in alluvium weathered from sandstone and Franciscan Complex rocks. Surface runoff is slow or medium, and the hazard of water erosion is slight or moderate. The shrink-swell potential is moderate. The effective rooting depth is sixty inches or more.

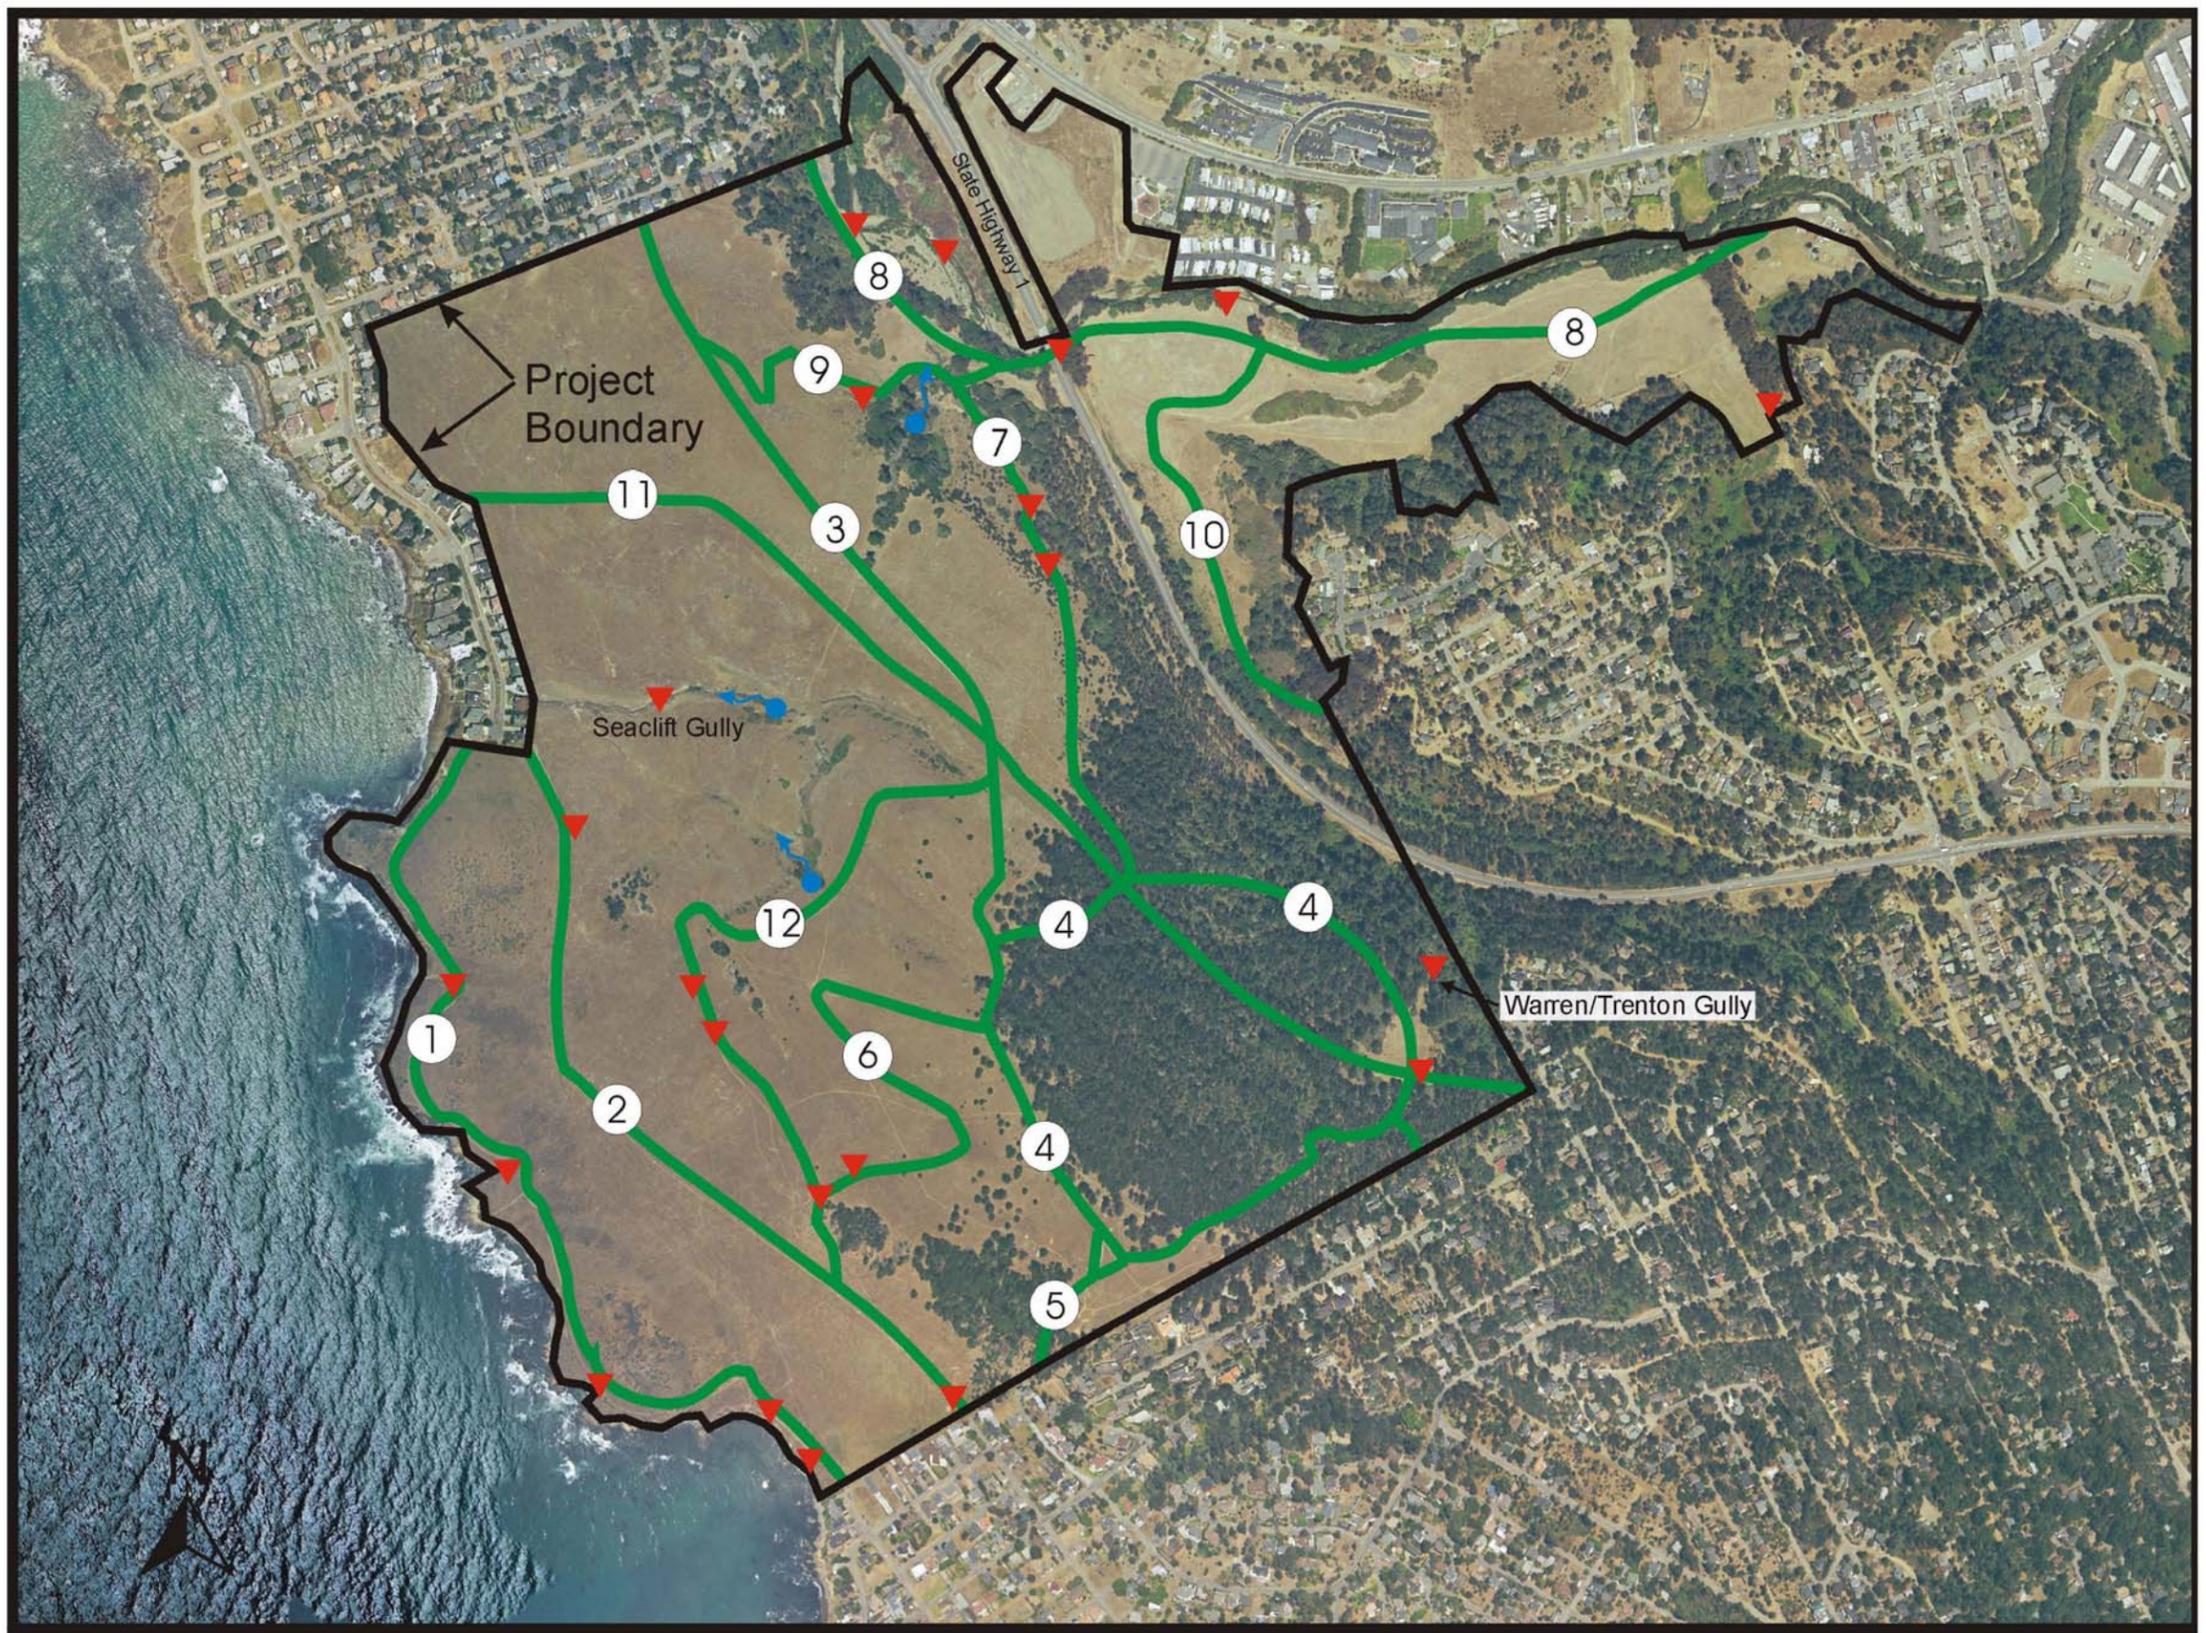
Area of erosion
  - ① Bluff Trail
  - ② Marine Terrace Trail
  - ③ Ridge Trail
  - ④ Forest Loop Trail
  - ⑤ Victoria Lane Trail
  - ⑥ Meander Trail
  - ⑦ Creek to Forest Trail
  - ⑧ Santa Rosa Creek Trail
  - ⑨ Creek to Ridge Trail
  - ⑩ Ramsey Trail
  - ⑪ Wallbridge Trail
  - ⑫ Terrace to Ridge Trail

Source: Cleath & Associates

Base Map: by AirPhoto USA  
Scale: 1 inch = 780 feet

Project improvements near the coastal bluff include a trail system and some soil stabilization work associated with the trail. Erosion and subsequent landward retreat of the coastal bluff will affect the long-range design and location of the bluff trail system. Previous studies addressing bluff retreat on or near the West FRP have been performed. These include onsite study reports by R.T. Wooley (1982) and Donald Asquith (February, 2005); and two bluff retreat studies performed on a private property at the northern cove by Cleath & Associates (1987 and 1998). These reports found that the coastal bluff along the West FRP is eroding.

This retreat rate is based on limited observations over 57 years, and rates may change over short periods of time within small portions of the bluff top. Onsite observations and oblique aerial photos revealed that portions of the bluff face in the northern cove can fail episodically and lose up to a few feet in one event. A network of tensional cracks on the bluff top above the northern cove was also noted, suggesting that the bluff top is unstable.
